# Manhole Inspection Summary

Manhole # S61K\_\_007MH

Insp Date: **7/8/08 11:40 AM**

**Location** Address: **rear 900 s ponca st**

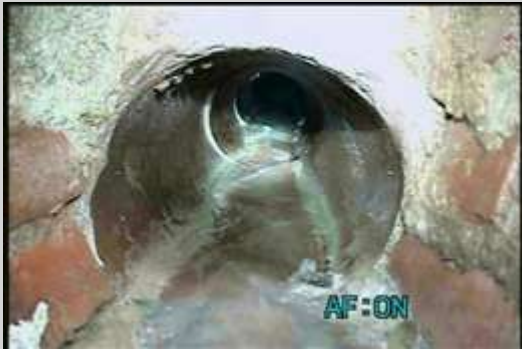
12 O'Clock Outflow

8 in. Circular Gravity Sewer  
Pipe Out @ 12 O'Clock

Pipe Material: **Clay** ☐ Pipe Lined

Invert Depth: **9.15** (ft.) Flow Characteristics: **Fast**

Deposits: ☒ None ☐ Mud ☐ Sludge ☐ Debris ☐ Grease

Infiltration: **None** Pipe Seal Cond: **Unknown**

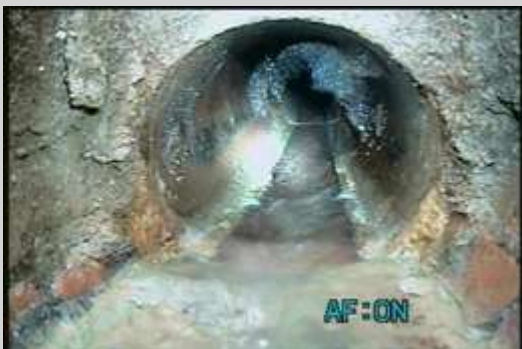
6 O'Clock Inflow

8 in. Circular Gravity Sewer  
Pipe In @ 6 O'Clock

Pipe Material: **Clay** ☐ Pipe Lined

Invert Depth: **9.00** (ft.) Flow Characteristics: **Fast**

Deposits: ☒ None ☐ Mud ☐ Sludge ☐ Debris ☐ Grease

Infiltration: **None** Pipe Seal Cond: **Unknown**

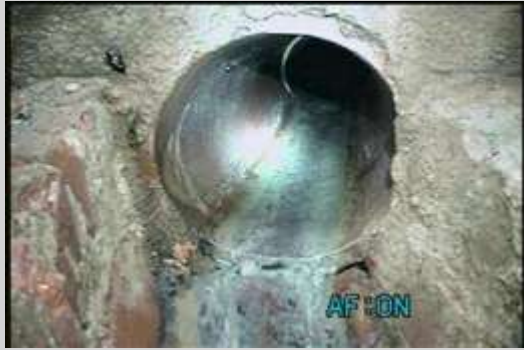
9 O'Clock Inflow

8 in. Circular Gravity Sewer  
Pipe In @ 9 O'Clock

Pipe Material: **Clay** ☐ Pipe Lined

Infiltration: **None** Pipe Seal Cond: **Unknown**
